DAM SUMMARY SHEET

Dam Name: IDA LAKE
County: DOUGLAS
Latitude: 45.95219

NID#: MN00176
Section/Township/Range: S26 T129N R38W
Longitude: -95.41662

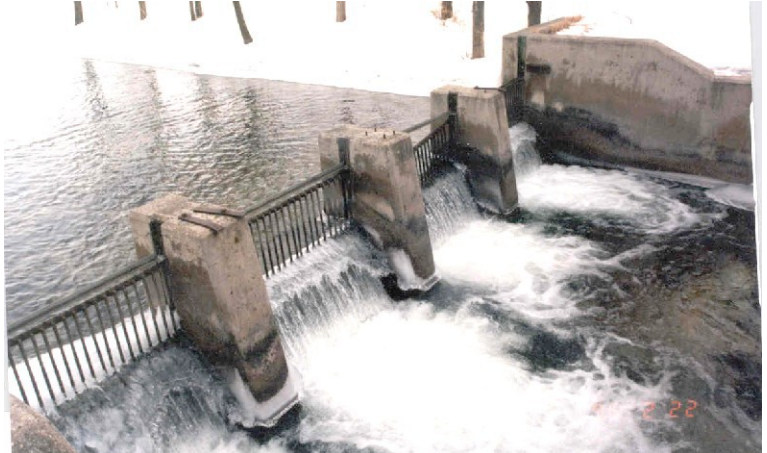
The dam is in good condition and is functional. The concrete is in good condition, and its weathering loss in general is better than what is expected for dams of this era (less than one inch of surface lost). The dam has been altered by removal of catwalk and the addition of trash guards. The earth fill in the abutments has settled slightly.

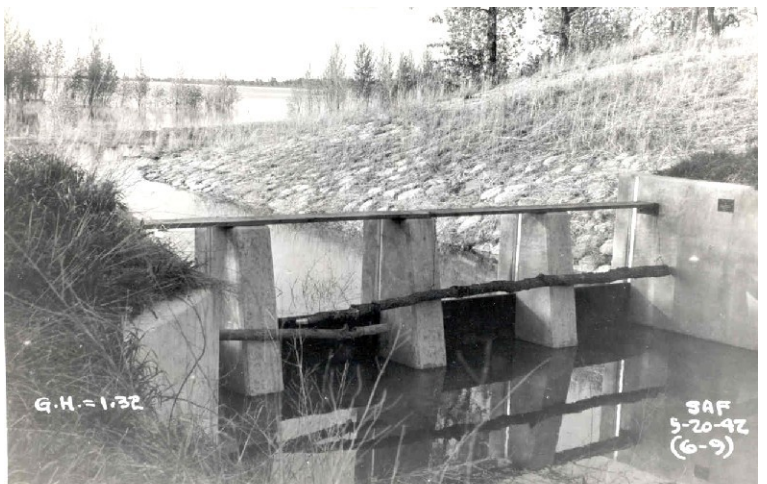
The dam is a Works Progress Administration project built for lake level control and to provide employment opportunities. It was built in 1937. The dam has 4 stop log bays, with each being 4 feet wide. It was authorized to have 1.9 feet of stop logs in place. It was built without a hand railing on the downstream side or around the perimeter of the abutments. It was built with a wooden catwalk.

The earthen slopes around the abutments and shoreline were paved with hand-placed fieldstone.
